Survey Summary

Survey Name	Maintenance 12.-13.02.2020
Survey Start Time	13.2.2020 14:43:51
Survey Start Time	13.2.2020 14:43:51
Company Name

Vorstellung der Schallkamera Fluke ii900 mit einem kleinen Leck an ca. 3 bar

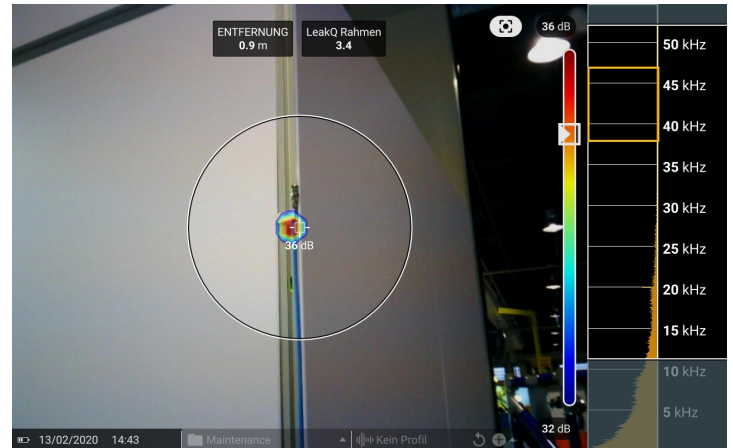
File	Maintenance_0009.as2
Leak Number	9
Type

LeakQ Rate Capture
Folder Name	Maintenance
Date and Time	13.2.2020 14:43:51
Distance	0.9 m
LeakQ Rate	3.4
Measured dB Level	44.3
System pressure in bar	7
Estimated Leak Rate	1.9 l/min
Estimated Costs	26 CHF/year

Das Leck wurde mit einer sehr dünnen Nadel in den Schlauch gestochen, der Leckdurchmesser beträgt ca. 0.1 mm
